Head Coho Cove
101-41-12
5-11-73

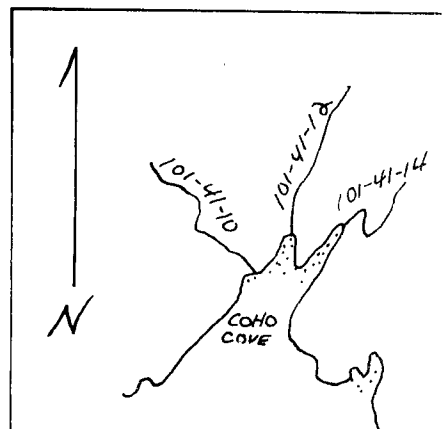
6 : stopped here. 20' barrier falls. 10 minutes to lake.

Mostly bedrock. Stream is narrow = torrential. Higher elevation. Scrubby timber. Spawning potential is zero.

Still steep gradient some slumping - could be soils problem if logged. 4"-6" gravel. Swift flow but some limited spawning potential.

Banks still steep. A little slumping in this area. Some limited spawning potential.

The best spawning and utilization is from this point downstream. Banks fairly stable to this point but becomes unstable upstream.

Trib. 1.

Generally brushy along the stream and hard walking. Some trees in and across stream but not excessive.

Small islands

2.5' falls over log

Small open area with slumping and a few trees down.
